# HAZ CHARACTERIZATION OF GTD-111 NICKEL BASED SUPERALLOY WELDING

Heat Affected Zone (HAZ) of TIG welded Ni base GTD 111 superalloys using various filler materials is investigated. The characterization is done based on microstructure observation and hardness estimation. The microhardness mapping indicates that the HAZ's are restricted to an area within 1 mm from the weld junction, independent of filler materials used. The microstructure evaluation shows that size of  $\gamma'$ , which precipitates coherently within the matrix, appear to be unchanged, while some MC type carbides break-up are detected within the HAZ. Fine intergranular microcracks associated with grain boundary liquation are observed at the weld junction transverse to the weld bead. Detailed chemical analysis indicates that the edge of cracks are Al and Ti rich, which are known to produce  $\gamma'$  precipitate in Ni superalloy. It is suggested that liquation of  $\gamma'$  along grain boundaries occurrs during welding and contributes to HAZ cracking in GTD 111 similar to other report on precipitation hardened Ni based superalloy.

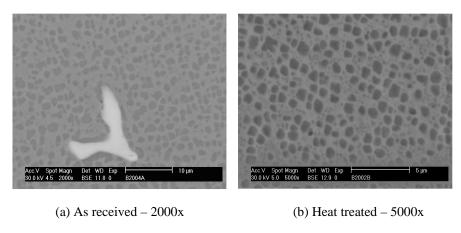
Figure 1. SEM images of GTD 111.

grain size, carbide particles, and  $\gamma$ - $\gamma'$  eutectic are unaffected by 2 hours solution heat treatment at 1120°C. Microstructure analysis using SEM shows that the received GTD 111 exhibits bimodal distribution of  $\gamma'$  precipitate with size ranging from 0.5-3.0  $\mu$ m as shown in Figure 1. After solution heat treatment,  $\gamma'$  size become smaller to a range of 0.5-1.5  $\mu$ m and their interparticle spacing increase resulted in reduced of  $\gamma'$  volume fraction. No significant change is observed on the carbides and  $\gamma$ - $\gamma'$  eutectic. Hardness is found to slightly decrease from 425hv to 410hv on average after solution heat treatment.

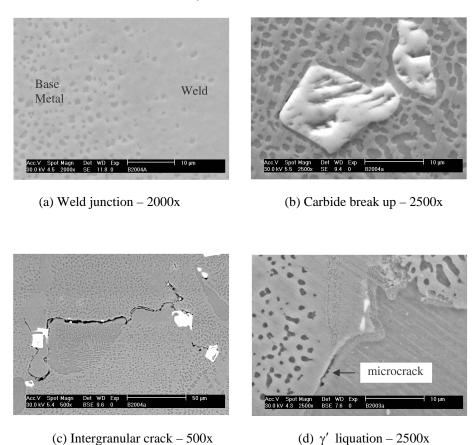
Figure 3. SEM images in HAZ.

Figure 3(a) shows weld junction of GTD 111 material. Weldment microstructure possess fine grain of solidified microstructures with no evidence of  $\gamma'$  precipitation. The result is expected as added filler material contained lower amount of Al and Ti that are responsible in formation of  $\gamma'$  precipitate with empirical formula of Ni<sub>3</sub> (Al, Ti), where Al can be substituted for Ti. On the other hand, GTD 111 base metal contains uniform distribution of  $\gamma'$  precipitate within the matrix which serve as primary strengthening mechanism.

Detailed microstructure analysis on the HAZ region within 1.0mm from weld junction reveals presence of disintegrated carbide particle as shown in Figure 3(b). Surface crack and decohesion of carbide-matrix surface are clearly visible. The phenomenon could be explained due to brittle nature of carbides and its inability to absorb sudden stress changes as a result of temperature gradient due to welding. Chemical analysis of carbide particles confirms that the carbides are MC type with rich amount of Ti and Ta.

In addition to carbide break up, number of intergranular crack are observed on the HAZ. The crack appears to be associated with grain boundary liquation as evidenced in Figure 3(c). Chemical analysis on the edge of crack indicates presence of high amount of Al and Ti compare to the matrix. The finding suggests that constitutional  $\gamma'$  liquation may have taken place at HAZ grain boundary during welding, similar to previous studies by Ojo et al. [3-5]. On separate study, Zhong et al. [9] characterized boundary liquation in directionally solidified nickel based superalloy into five (5) types. Close examination of certain large  $\gamma'$  precipitate in the HAZ shows evidence of liquation and boundary decohesion as in Figure 3(d).
